TRENCHLESS TECHNOLOGY RESOURCE CENTRE	
	TRENCHLESS TECHNOLOGY GUIDELINES	SECOND EDITION
	MANHOLE REHABILITATION TECHNIQUES	LAST UPDATED OCTOBER 2006

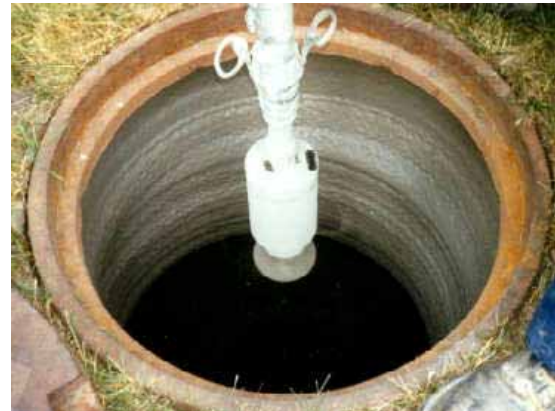
Spray lining of a manhole with a specially designed spray nozzle.

Here a manhole is first cleaned to remove debris and to create a bonding surface for the sprayed compound product to adhere to. A special spray nozzle (various systems are available to the market) is then utilised to apply a grout product to the inner wall of the manhole. The product may be cementitious or polymer based depending on the criteria required of the lining, the preferred choice of the client and the final product requirements in terms of operating conditions expected. The spray system can be designed to be applied in as thick a coating as required. Many of the systems available may require a level of manhole pre-treatment if infiltration is high, simply to prevent washout of the spray coating before curing is complete by stopping inflows (see above).

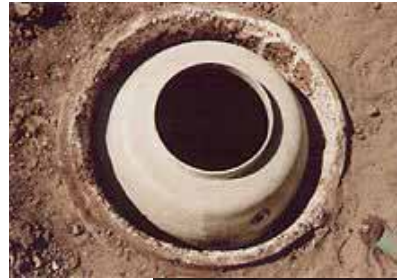
◀ A liner inserted into an existing manhole.

Preformed Sections: This type of lining, as in mainline sewer rehabilitation, comprises the use of factory-built units, either of standard dimensions or specially constructed design to the measured dimensions of the manholes under rehabilitation. Sections can be of concrete or plastic but are more usually designed from Glass-reinforced concrete (GRC) or Glass-reinforced plastic (GRP). The sections are usually designed in single monolithic sections that are positioned within the manhole structure. Once in place the annulus between the new liner

and the existing manhole wall is grout filled to form the permanent bond between liner and existing manhole, making the new lining an integral part of the manhole and so part of the structural integrity.

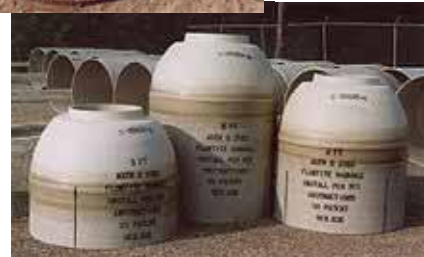
Preformed Manhole liners. ▶
Picture courtesy of Containment Solutions Inc

Standard units are available for manhole depths from 0.9 m to 7.5 m, and with inside diameters from 1,066 mm to 1,830 mm. Manufacturers can supply non-standard units on request.

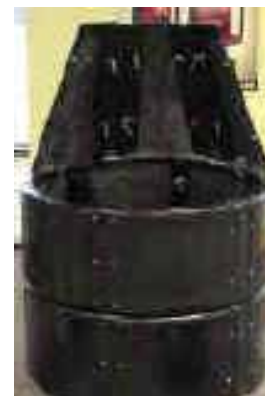
A typical manhole rehabilitation former, shown in a manhole above left. Picture courtesy of Improved Construction Methods.

Poured-in-Place: Poured-in-place systems are very much self-explanatory, in that what it says is what you get. The technology relies on the placing, in the manhole to be rehabilitated, a formwork to the shape and size of the required lining. The formwork can be of either steel or plastic material and is available in a variety of standard sizes depending on the manufacturer used. They can also be custom-made to specified dimensions. With the formwork in the manhole concrete is poured around it, often using vibration to ensure the concrete settles correctly, and fully fills the formwork's annulus. Once the concrete is full to the top of the former it is allowed to cure according to the concrete curing specification.

Once cured the formwork is removed from the manhole to leave the new liner in place.

If a plastic inner wall liner is required as a final product in the manhole, it is also possible to design a plastic skin that is placed around the outer surface of the former during its construction. The design allows for the plastic to anchor into the concrete as it is poured, so creating an integrated concrete/plastic liner within the manhole.

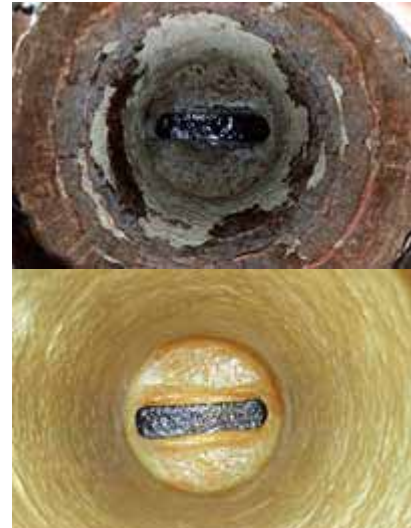
CIPP manhole rehabilitation before (top) and after (bottom).

With the product fabric chosen, the liner is inserted into the manhole under repair from the top of the manhole. Once in the manhole the liner is 'inflated' using a flexible bladder that is itself inflated with compressed air. This pushes the liner against the existing manhole wall where it is allowed to cure. Once cured, the bladder is deflated and removed leaving the liner in place.

Once cured, the liner is cut in the relevant places to reopen lateral connections should there be any, and to open the base inlets and outlets.
